Case Study: 830E WHEEL MOTORS

Iron Ore Company of Canada

APPLICATION: Wheel Motor Lube Oil

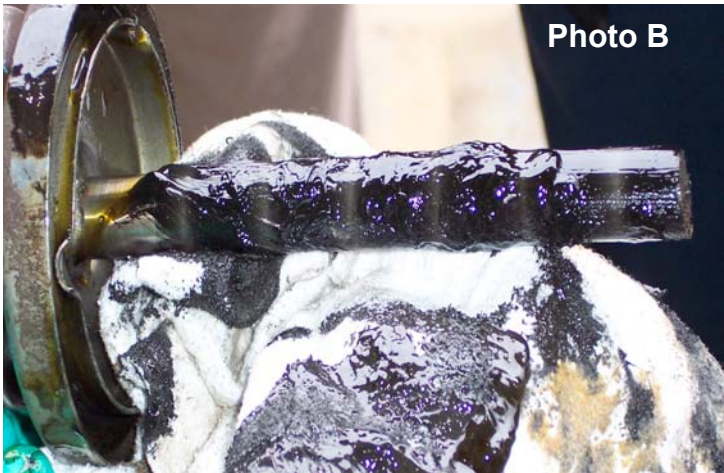
RESULTS: Photo B shows the results of the magnetic filter after only 452 hrs. Having the magnetic filter designed into the filler cap allows for continuous inspection which also works as a predictive maintenance tool.

SOLUTION: Installation of OEI's Magnetic Filter filler cap design (25RFC787) in place of the manufacturers' filler cap.

If an increase in contamination is noticed proper actions can be taken. Without this tool an increase in ferrous contaminants would not be noticed until oil analysis is taken.

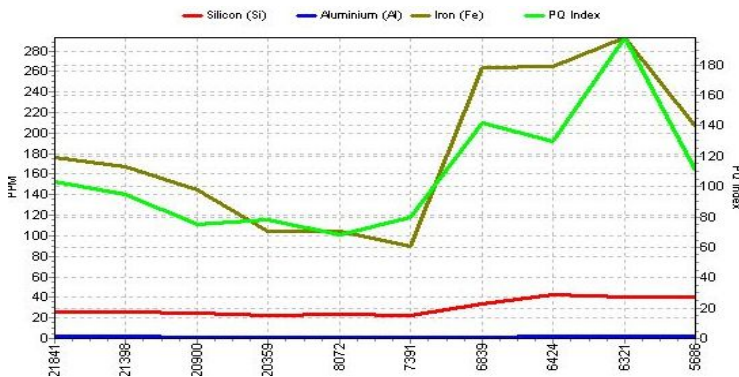
The graph shows the results of installing the magnetic filter at 6839 hrs of operation. The Fe ppm dropped from 260 to 90 and is being filtered to submicron levels. Continuous filtration will lower the contamination levels and keep them low thereby extending component and lube oil life.
