**Case Study: Pulp & Paper Slurry Filtration**  
July 2012

**PT. Tjiwi Kimia**  
**Pulp & Paper Mill**  
Indonesia

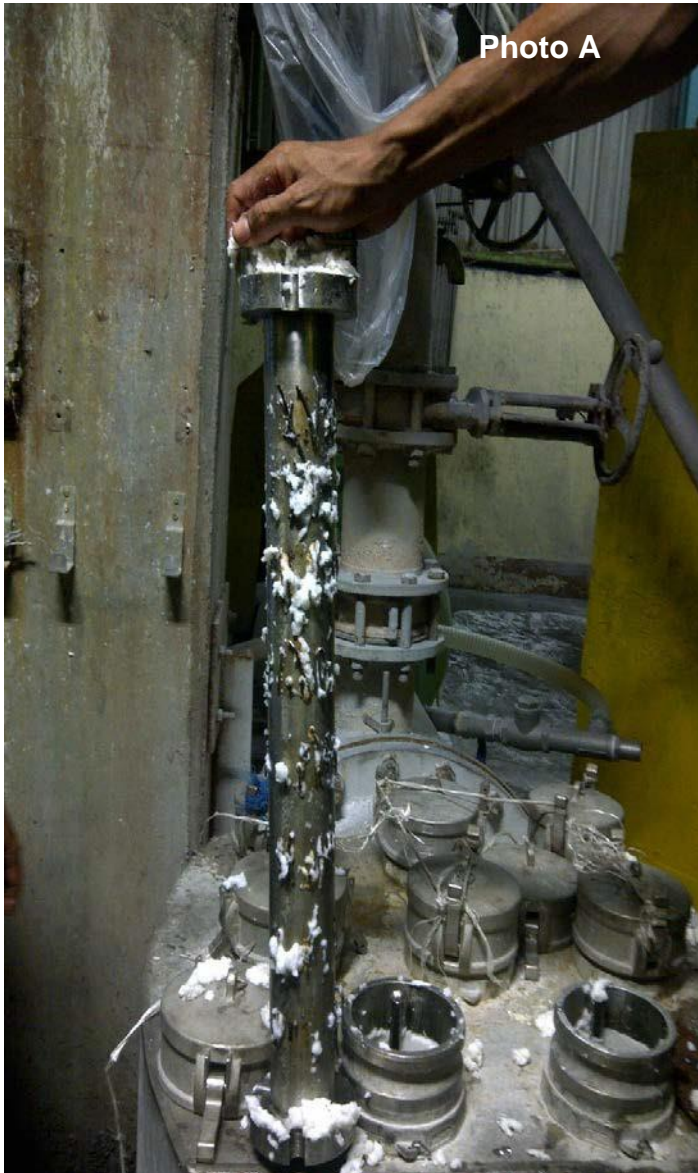
**RESULTS:** Photo A shows a close up of a substantial amount of ferrous wire contamination captured by the OEI magnetic filter rod in the pulp slurry mixture after only eight hours in operation.

**PROBLEM:** The slurry pump and its components have been subject to premature wear due to excessive amount of bale wire contaminating the pulp slurry mix. The current magnetic filtration system was unable to remove the majority of this wire.

**SOLUTION:** Beny Hermawan of PT. Sinarmentari Indoprime, the OEI distributor in Indonesia, recommended the installation of OEI's 3000 Series magnetic rod (3RNC5812) to replace the unit's current, insufficient magnetic filtration system.
