CASE STUDY

GILDERMEISTER MILLING MACHINE

COOLING / CUTTING FLUID

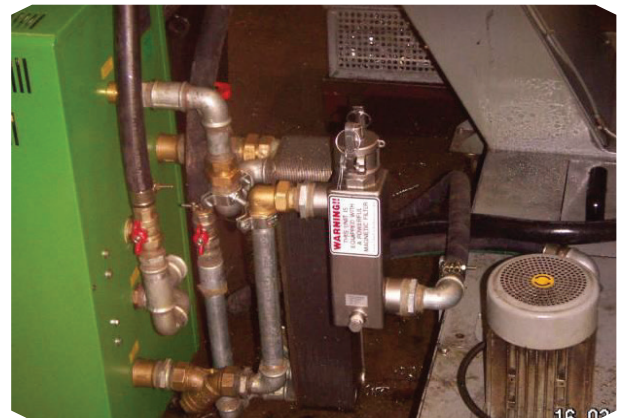
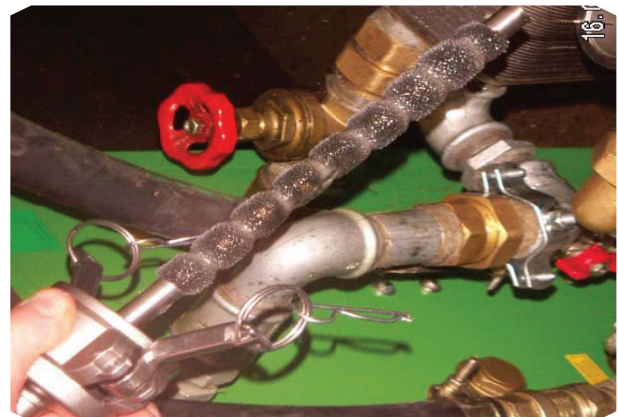
After 2 hours of operation, the cooling system was operating at a temperature of 19° C. To date, the OEI magnetic filter scrubber continues to extract ferrous particles that the OEM filters fail to capture.

Flush the system and deploy an OEI magnetic filter scrubber on the cooling line to maintain operating temperature, and protect the pump and radiator.
